# HILLA MATERNITY AND CHILDREN'S HOSPITAL HILLA, IRAQ

SIGIR PA-05-016 MARCH 13, 2006

#### Hilla Maternity and Children's Hospital

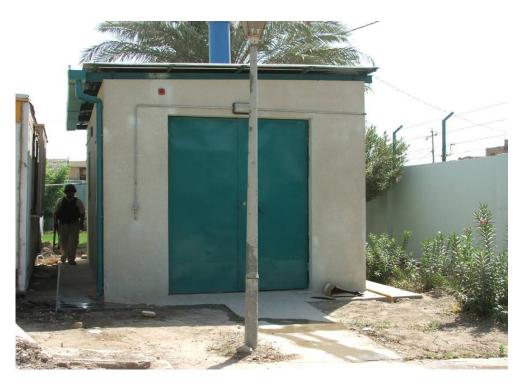
Our site assessment verified the exterior structure was complete. At the time of our site visit, the gas powered, electrically controlled incinerator unit was installed and electrical connection completed. The incinerator unit factory name plate listed the following: Company - Muller, Make - Group ATI Incinerator, Type - CP 15, and Rated Capacity - 15 kg/hour. The incinerator and structure appeared consistent with contract and design requirements. Site Photo 1 shows the exterior view of the incinerator building. Site Photo 2 shows the installed incinerator unit and controls.

Site Photo 1. Exterior View of the Incinerator Building

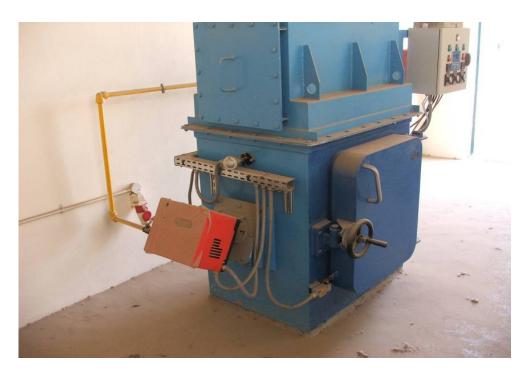
Site Photo 2. Installed Incinerator and Unit Controls

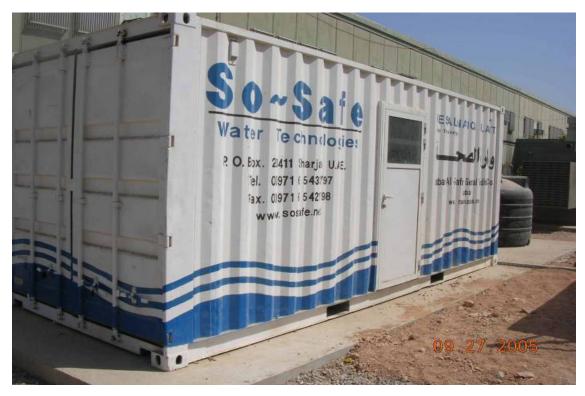
The contract required the "installation of a water filtration/purification system to ensure a potable water supply for the building, with relevant standards for supply and control of water to clinical areas such as operating theatres. Assess the need for a reverse osmosis system." The design required the supply and installation of a 6,400 gallons-per-day reverse osmosis unit. The unit is containerized and designed for expedited deployment. The reverse osmosis unit and associated filtration units were selected to treat water to a potable level. The site visit did not include an inspection of the reverse osmosis unit. Review of the USACE QA daily reports and photographs have confirmed the reverse osmosis unit was installed and the unit appeared to be consistent with design and specifications. Site Photo 3 shows the exterior of the reverse osmosis containerized unit. Site Photo 4 shows the raw water tank and high pressure feed pumps.

**Site Photo 3. Exterior Reverse Osmosis Containerized Unit** (Photo courtesy of the USACE QAR)

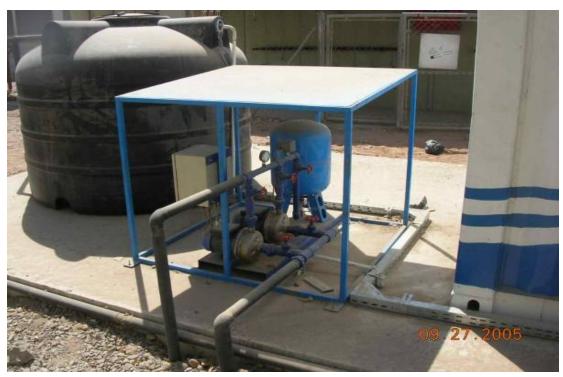
Site Photo 4. Raw Water Tanks and High Pressure Feed Pumps (Photo courtesy of the USACE QAR)

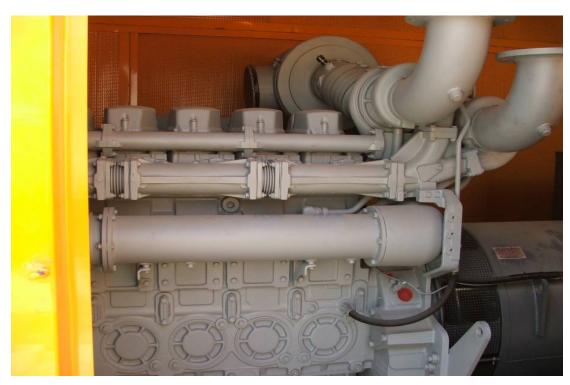
The contract required the contractor to "repair or replace critical power (generator) back-up power". The design required, as a component of the back-up power, the supply and installation of a 1,000 kilovolt-amp generator for emergency backup power. Our site assessment verified a containerized generator unit was located onsite, although electrical connections had not been completed. The generator unit factory name plate listed the following: Company – Stromerzeuger; Generating set power – 1,000 kilovolt-amp; Production Year – 2005; Engine Make – Perkins; Engine Model - 4008TAG2A; Engine Serial Number – U5365M; Alternator Make – MECC ALTE; Alternator Model Number – ECO43-1LN, and Alternator Serial Number – 1106907. The generator unit appeared consistent with the contract and design requirements. Site Photo 5 shows the generator motor and alternator. Site Photo 6 shows the factory nameplate of the generator unit.

Site Photo 5. Generator Motor and Alternator

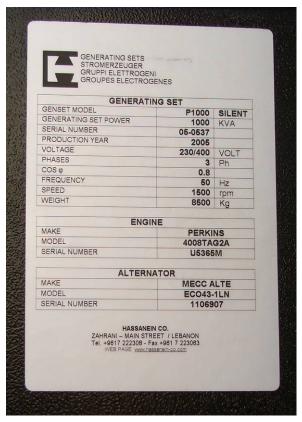
Site Photo 6. Factory Nameplate of the Generator Unit

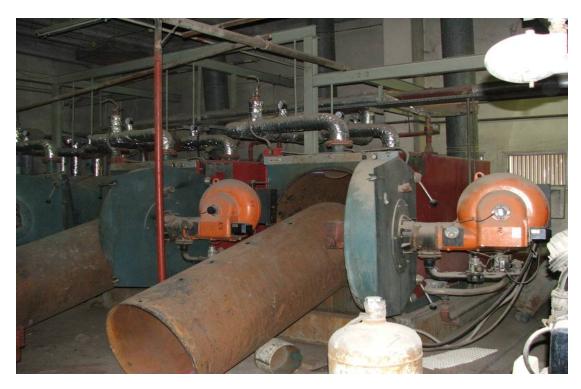
The contract required the assessment of existing conditions, and, if required, the repair of existing boilers or installation of new boilers. The hospital has three existing boiler units located in a ground floor mechanical room. An assessment of the boiler units is currently underway by the contractor to determine if repair is feasible or whether new units will be required. At the time of our site visit, the boiler units were partially dismantled in order to assess their condition. Currently, the assessment is not complete; therefore, a decision has not been made to either repair or replace the units. Site Photo 7 shows a partially dismantled boiler unit.

Site Photo 7. Partially Dismantled Boiler Unit

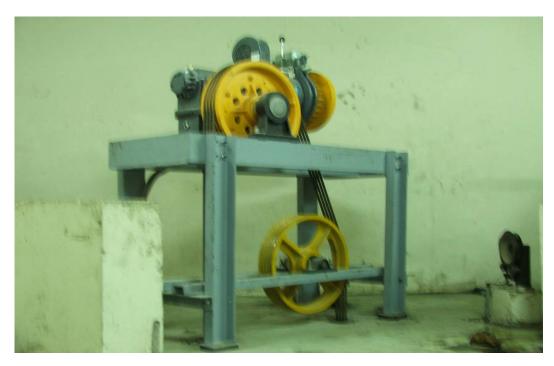
Our site visit verified that rehabilitation of the elevator systems was ongoing. Site Photo 8 shows a newly installed motor for an elevator unit. Site Photo 9 shows the inside of an elevator shaft. The assessment team did not possess the expertise to evaluate the elevator systems. We interviewed the USACE Elevator Specialist for Iraq, and reviewed the elevator QA reports. The USACE Elevator Specialist inspected two elevator systems at the Hilla Maternity and Children's Hospital on 6

Site Photo 8. Newly Installed Motor for the Elevator Unit

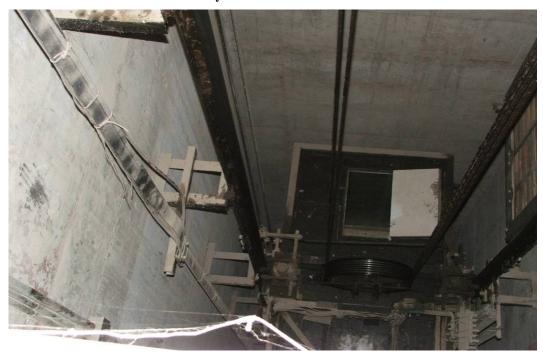
To date, most of the issues have been resolved, but several items are still pending, specifically lock out/tag outs, required equipment guards, and the HVAC upgrade in the mechanical room. Per discussion with the PCO project manager, two elevators have been approved for use, although the elevators have not been officially accepted as complete due to the required additional work.

Site Photo 9. Inside of the Elevator Shaft

- 1. Direct the contractor to implement elevator procedures sufficient to correct the problems.
- 2. Require a qualified elevator specialist to perform final quality assurance elevator inspections.
